**EMERGENCY SPILLWAY PERFORMANCE,
UPPER RED ROCK CREEK WATERSHED,
OKLAHOMA**

ARS-S-108

May 1976

By W. O. Ree¹

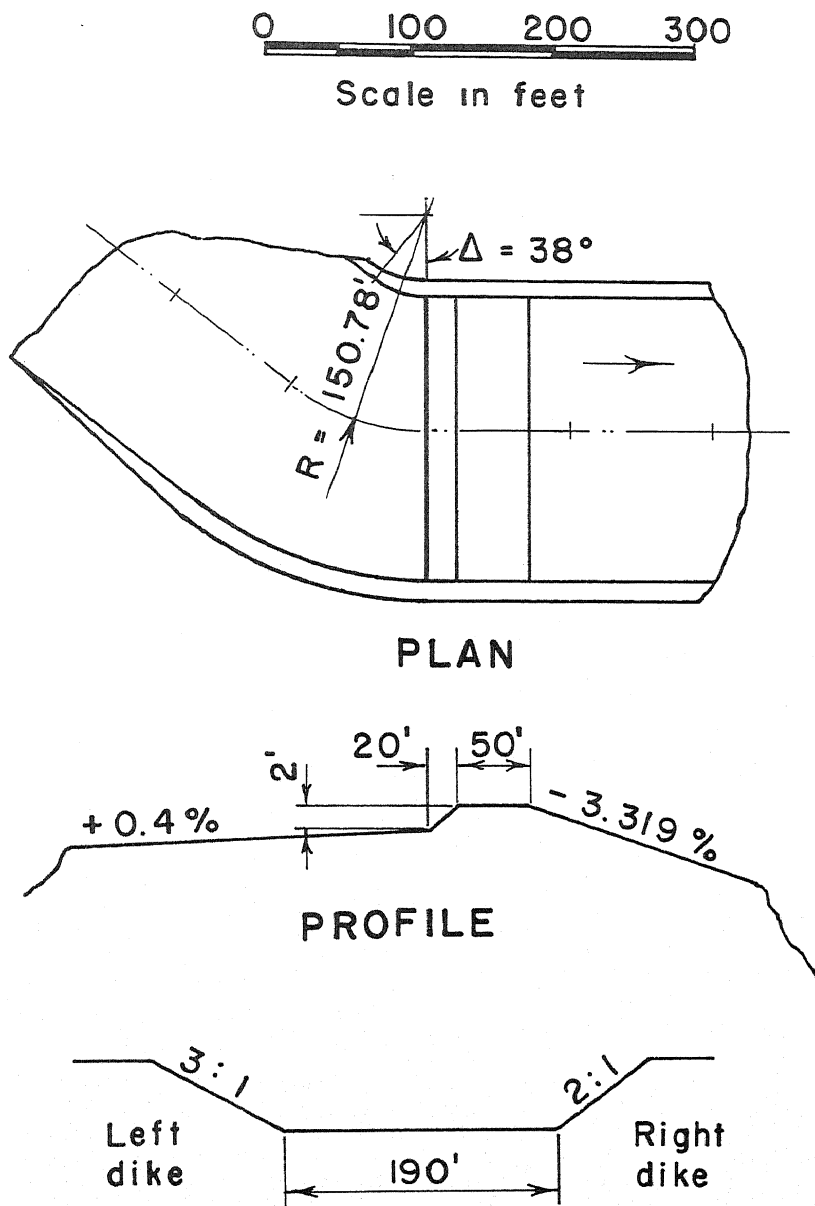
FIGURE 2.—Emergency spillway dimensions, site 24.

The emergency spillway is an earth channel around the right end of the dam (fig. 2). It was excavated in the red clay and shale of the site, topsoiled to a depth of 6 inches, and planted with ber-

mudagrass. At the time of the survey the noneroded area of the spillway had a poor stand of short, heavily grazed bermudagrass and a scattering of broomweed. The flow retardance was judged to be class E, based on the criteria in the Soil Conservation Service handbook.²

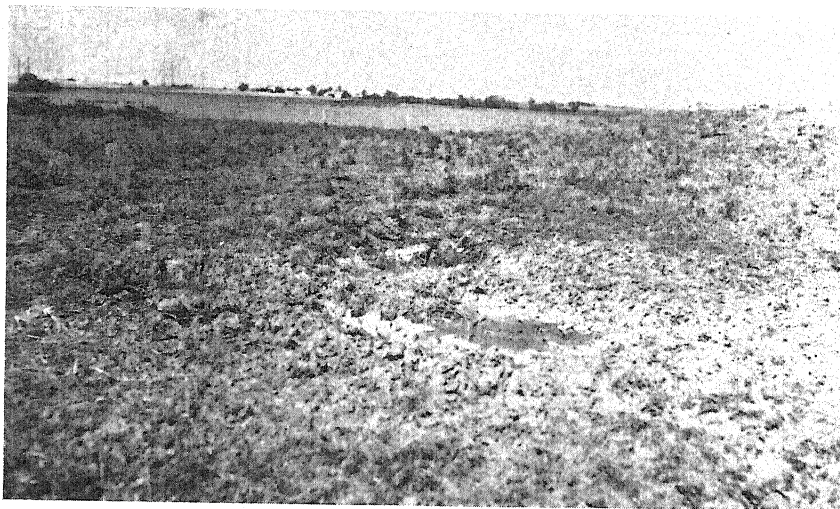
FIGURE 6.—Scoured area in site 24 spillway just downstream from spillway crest. The cover on the adjoining area is thin, poor, and short.

The site 24 spillway started to erode during a flow event which had a peak mean velocity of 6.7 feet per second. The spillway appeared to have been heavily grazed, and this may have been responsible for its condition. Cattle trails and “stomp” areas were present in the spillway at the time of inspection. Therefore, it is reasonable to assume that the eroded areas also had suffered from similar cattle activity.

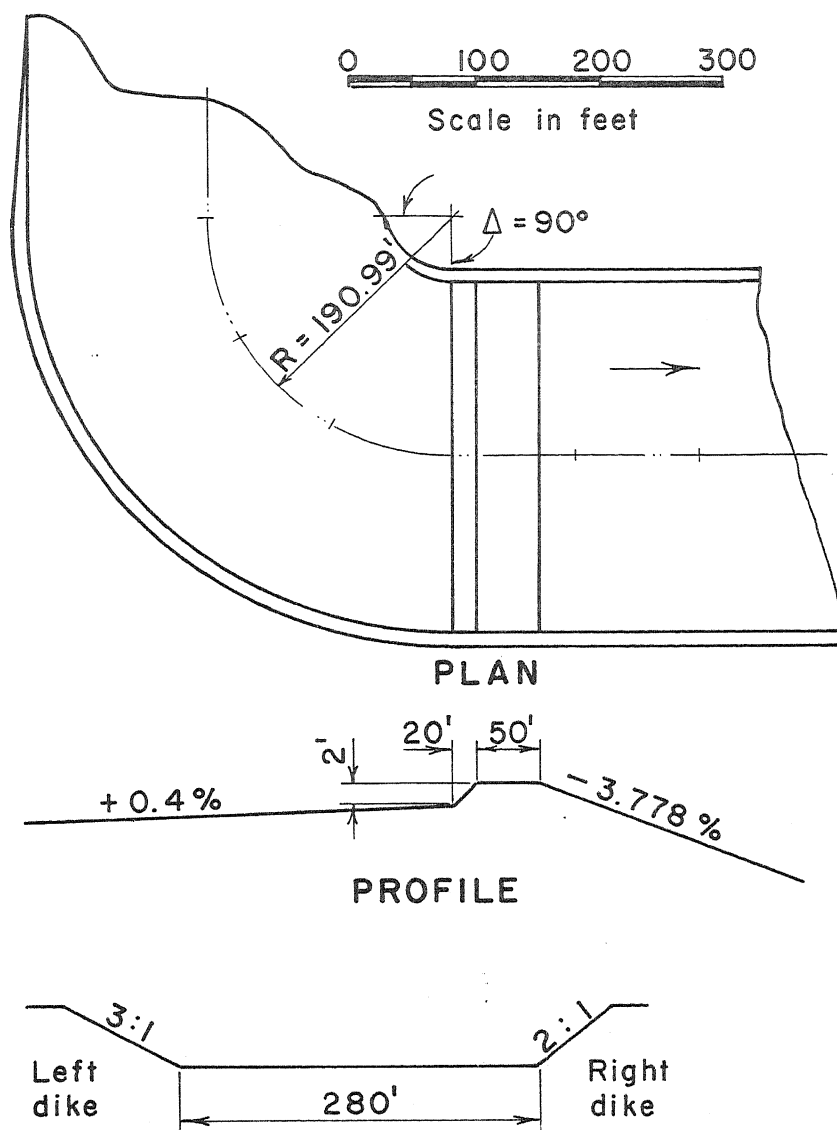
FIGURE 7.—Emergency spillway dimensions, site 25.

The emergency spillway is at the right end of the dam. Its dimensions are shown in figure 7. A minimum of 6 inches of topsoil had been placed on the spillway surface after excavation and shaping. At the time of the flood the spillway had a very uniform, good cover of bermudagrass, with a scattering of a short, fine-leaved grass and broomweed. The spillway had been grazed, and the grass was relatively short. Its flow retardance was estimated to be class E.

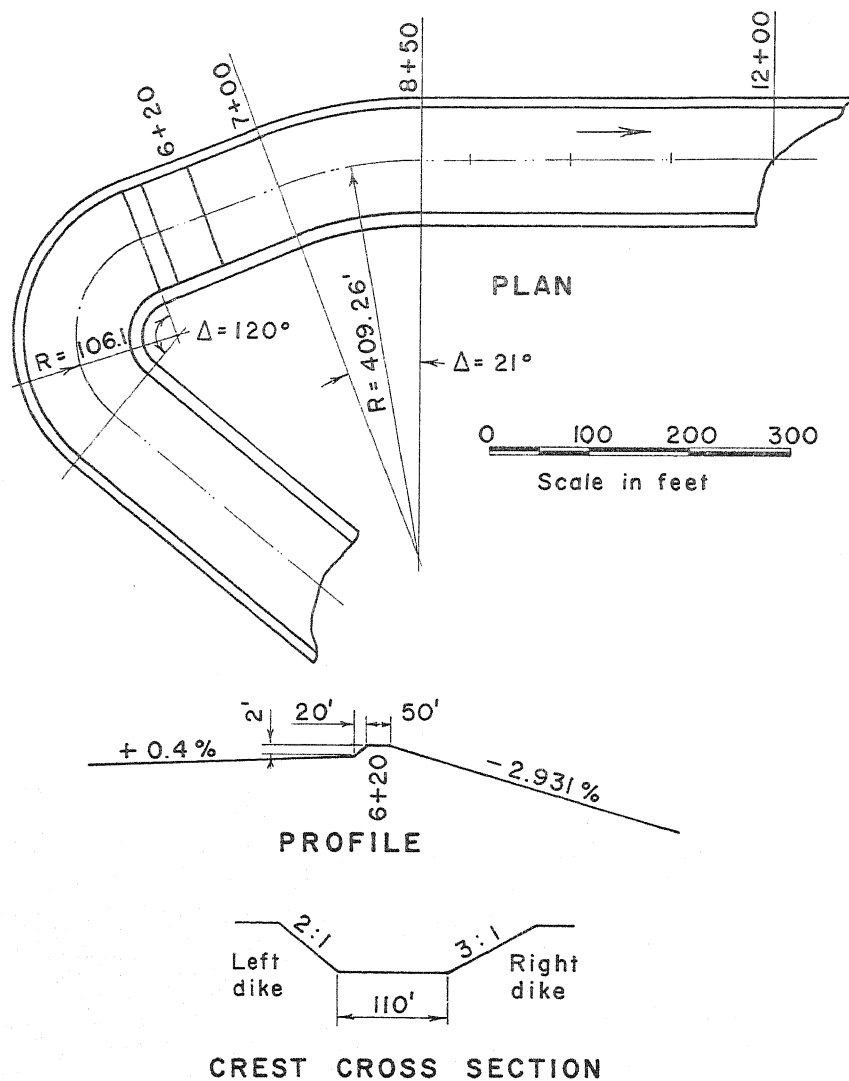
FIGURE 10.—Emergency spillway dimensions, site 30.

The emergency spillway is at the left end of the dam. Its dimensions are shown in figure 10. This spillway has two unusual characteristics. The crest is constructed in fill, probably not more than a foot or two deep, and there is a curve in the downstream reach of the spillway. Topsoil had been placed in the spillway to a depth of 6 inches and bermudagrass was established as a cover. At the time of the flood there was an excellent stand of bermudagrass on the crest and the upper part of the spillway. Toward the lower end of the downstream reach the grass cover was fair to good. The spillway had not been grazed prior to the flood. The overall flow retardance for the cover was estimated to be class C.

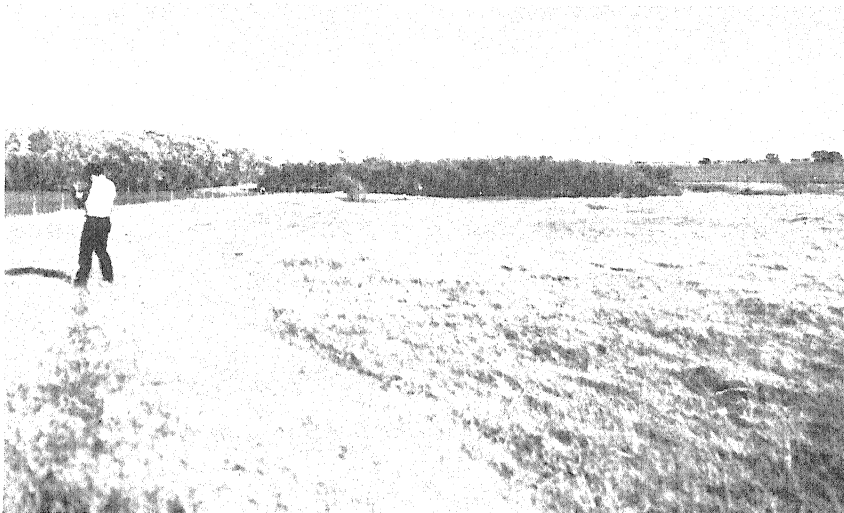
The flow velocity in the upper part of the spillway was estimated to have been 1.0 feet per second at the peak of the flood. This low velocity did not erode the spillway; the grass has hardly been disturbed. Figure 11 shows the crest of the spillway after the flow.

FIGURE 11.—Crest of emergency spillway, site 30. The cover is an excellent stand of bermudagrass.

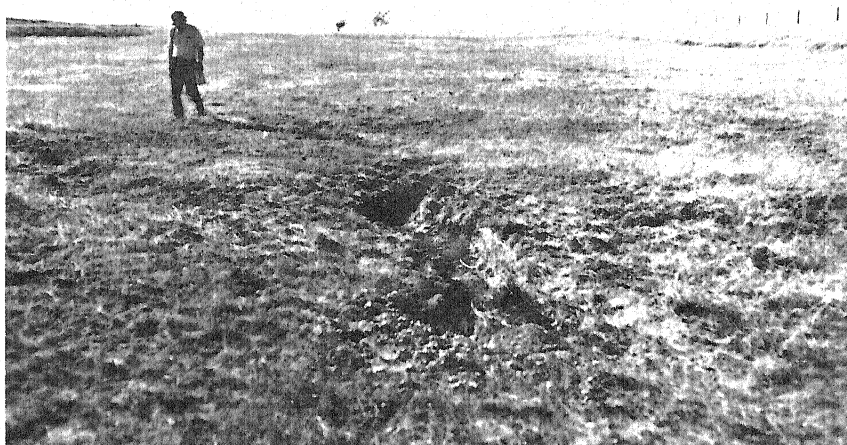
the topography of the site. A small gully has formed here (fig. 12). (It may have been there before, only to be enlarged by the flood.)

FIGURE 12.—Small gully at outlet end of site 30 emergency spillway. Concentration of flow and the poor cover may have caused this minor failure.

Second, at the outlet the spillway was gradually deepened at the centerline so it could join the existing draw in a smooth transition. The flow is concentrated at the deepest point of the spillway,

where the velocity is highest and where the gully starts. (It could eventually reach the center.) A level sill and a low drop structure at the terminal end of the spillway would eliminate the need for the deepening that threatens the stability of the spillway. This would be a practical solution only if the grass could be relied upon to provide protection against erosion in the channel upstream from the terminal structure. If the grass lining is not dependable, there would be no point in using a terminal structure because the spillway could still fail from erosion above the structure. Again, the exploration of this idea is left for future consideration.

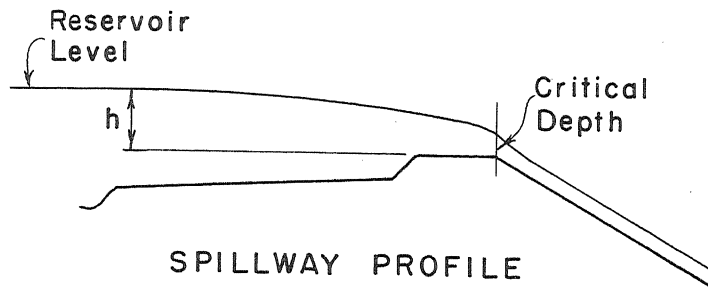
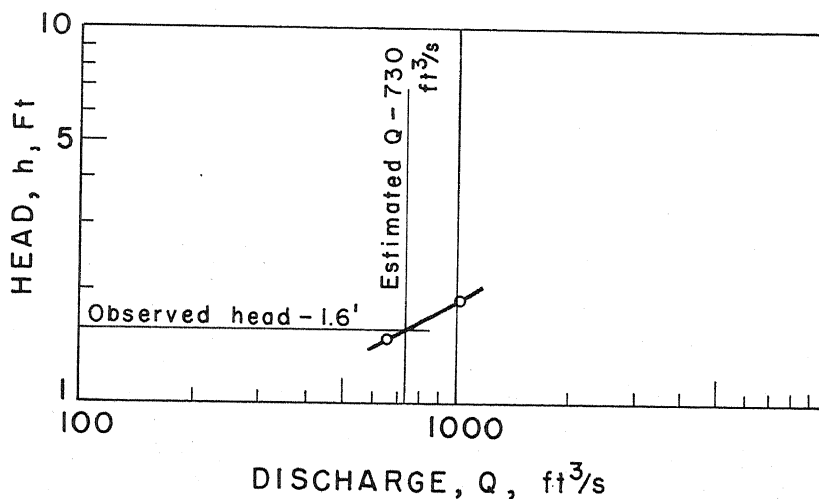
FIGURE A-1.—Rating curve for site 24 emergency spillway and estimated discharge for the flow event of October 10-11, 1973.

9. Enter figure A-1 with the storm peak head of 1.6 feet and read a discharge rate of 730 cubic feet per second.
